Electrical geophysical methods to study subsurface water movement in urban areas

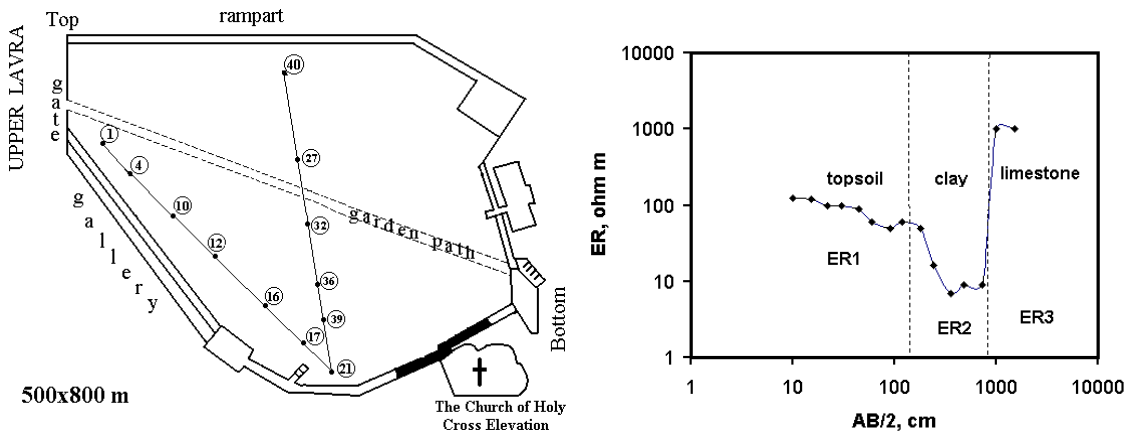
The VES and EP methods revealed complex stratification of the hill slope in the Patriarch garden near The Church of Holy Cross Elevation (Figs). All the VES curves revealed three-layer soil profile with apparent $ER_1 > ER_2 < ER_3$. The top layer was represented by the eroded Chernozem of coarse textures with electrical resistivity (ER_1) about 125 ohm m for loamy sand and about 50 ohm m for sandy clay loam. The second layer was a thick clay layer (7 m) with low electrical resistivity (ER_2) from 2 to 16 ohm m. The clay was saturated and gleyed in some places, which was indicated by 2 ohm m

resistivity. The third layer with the resistivity (ER_3) about 2000 ohm m was horizontally deposited limestone. The results of sounding were verified with boring at the same 12 locations. The thickness of clay layer decreased from 8 to 2 m along the line from the top of the hill to the tier wall. The low and almost constant electrical resistivity (8 ohm) for the AB/2 from 3.6 to 7.2 m for the second layer shown that clay did not bear any intrusions of sand or sandy loam, which was verified with boring. Therefore, water flow inside second layer was impossible. The water flow could be formed only in the topsoil over the layer of waterproof clay.

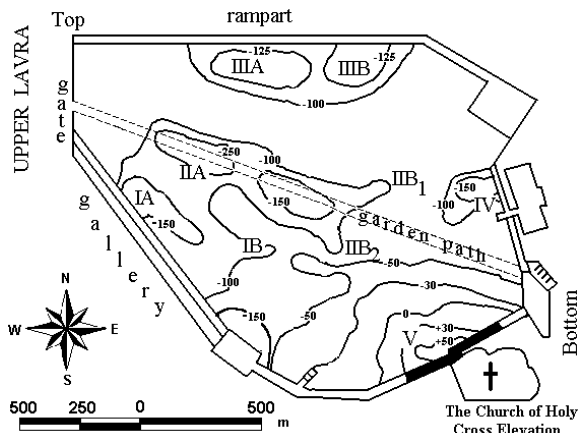
Although undetectable on the surface, three gullies were revealed in the second layer of waterproof clays by the VES and EP methods. The subsurface water flow could be formed in such gullies. The method of self-potential was used to estimate water flux directions and intensities through the measured variation in electrical potential on the soil surface. An iso-potential map (Figure) was developed with the method on a 5 x 10 m grid; 299 locations were measured with five replications. Three major iso-potential areas detected from the figure. Two areas with negative potentials were formed near rampart and along the gallery (including the garden path) and

indicated the areas of water infiltration into the soil and development of groundwater flow (I, II, and III). The third area with positive potentials outlined the seepage zone near The Church of Holy Cross Elevation (V). The most negative potentials (-250 mV) along the garden path indicated the most intensive subsurface water flow in this area (IIA, IIB₁, and IIB₂). The -250 mV iso-potential area developed in surface peaty sand with electrical resistivity (ER_1) about 170 ohm m. The less negative potentials (-150 mV) and, therefore, the less intensive water flow occurred near the gallery (IA and IB). The same negative potential areas were detected in the middle of the garden path and near the rampart (IIIA, IIIB, and IV). The seepage area was outlined by the 0 mV iso-potential near The Church of Holy Cross Elevation (V). The seepage area was enriched with clay material having electrical resistivity about 5 ohm m. The percentage of clay in the soil increased toward the corner of the church along with the electrical potential.

To protect The Church of Holy Cross Elevation, the following procedures were proposed based on our geophysical exploration near the architecture memorial. First, a hedge should be constructed across the gate to the garden to prevent the surface water flow to the Patriarch Garden from the pavement of Upper Lavra. Second, a small dike should be built perpendicular to the gallery and the garden path to direct subsurface water flow from fluxes II and I into the drain system. Third, to enhance evapotranspiration, trees and bushes with the intensive transpiration ability, such as willows and poplars, should be planted along the gallery and rampart, especially in the areas indicated by low potentials. All the measures were implemented in 1990 and still provide adequate preservation for the church and the surrounding caves. The cost of the proposed measures was about one twentieth of the previous construction of concrete wall, which, nevertheless, did not solve the problem of water penetration into the caves.
